COMPANY CARBIDE AND CARBON CHEMICALS COMPANY

DATE January 25, 1954

SUBJECT BELLOWS FAILURES IN K-29
SIX INCH G-17 VALVES

KLI-2808

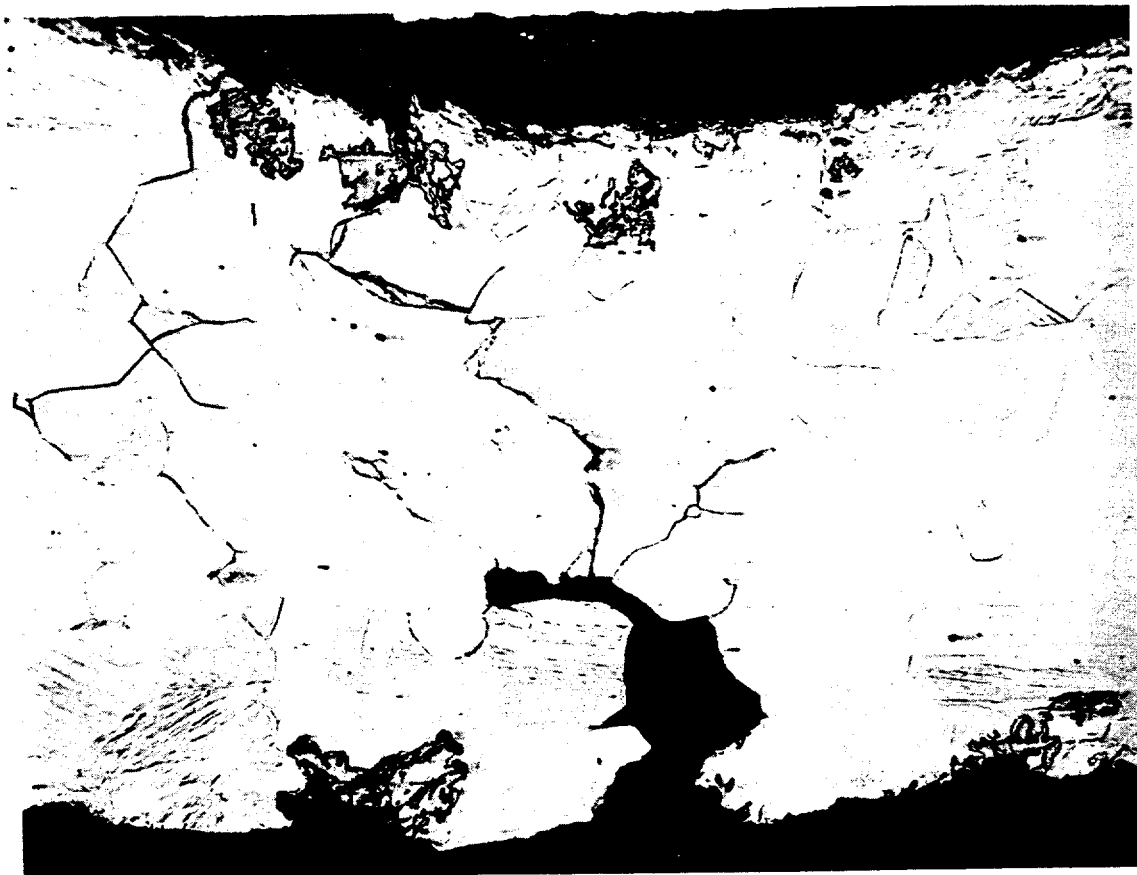
Figure 1

The bellows, identified spectrographically as brass (81% copper, balance zinc), failed because of stress-corrosion cracking as evidenced by the intergranular path of the failures. The cracking propagated from the inner surface of an outer convolution on one of the failed bellows and from the inner surface of an inner convolution on the other bellows. The inner surfaces also showed dezincification.

INTERGRANULAR PATH OF THE FAILURE

This photomicrograph illustrates stress-corrosion cracking which is evidenced by the intergranular path of the failure from the inner surface of an inner convolution. Also shown is the deposition of copper resulting from a dezincification attack of the brass. This sample was taken from the lower section of the first valve failure examined.

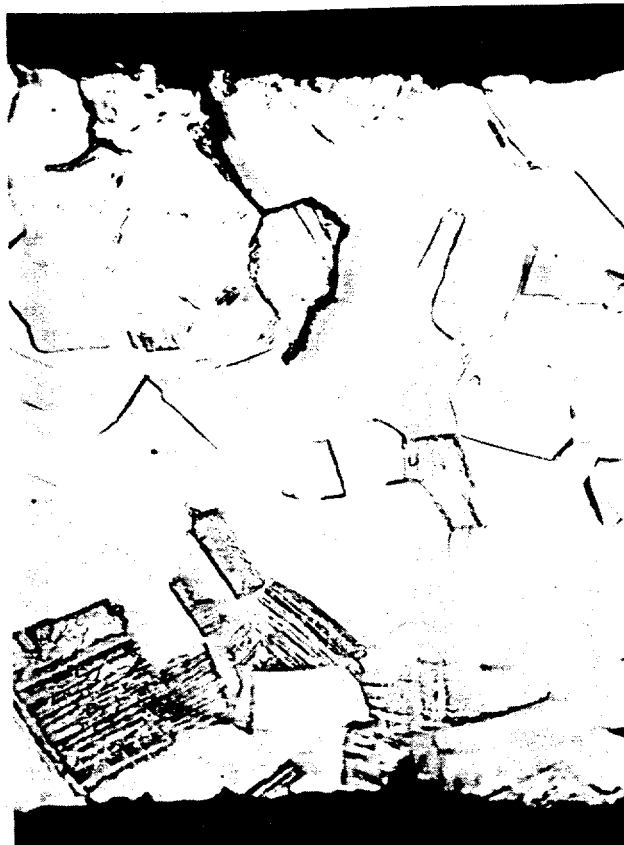
Figure 2

INTERGRANULAR PATH OF FAILURE

Stress-corrosion cracking originating from the inside surface of an outer convolution of the bellows. This bellows sample was taken from the second valve failure examined.
